**18-2247**  
16 August  
2018

**TECHNICAL SERVICE BULLETIN**  
**1.5L EcoBoost - Illuminated Malfunction Indicator Lamp (MIL) - DTCs**  
**P04DB And/Or P051B - Built On Or Before 1-Feb-2017**

<b>Ford</b> 2017 Escape
----------------------------

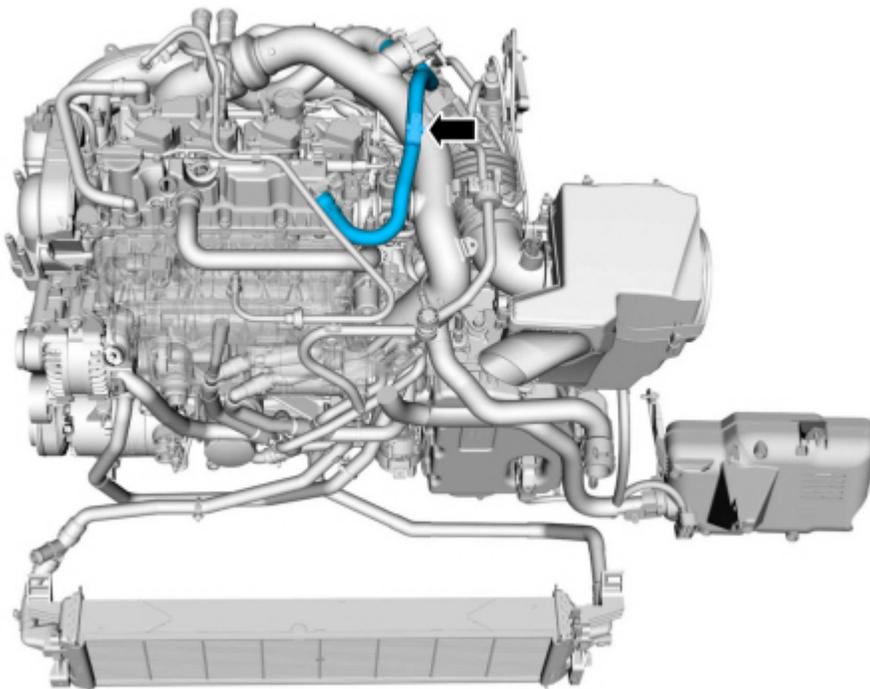
Figure 1

**Issue:** Some 2017 Escape vehicles equipped with a 1.5L EcoBoost engine and built on or before 1-Feb-2017 may exhibit an illuminated MIL with diagnostic trouble codes (DTCs) P04DB and/or P051B stored in the powertrain control module (PCM).

- (1). Yes - proceed to Step 7.
  - (2). No - proceed to Step 4.
4. Remove the cowl panel. Refer to Workshop Manual (WSM), Section 501-02.
5. Remove and replace the crankcase pressure sensor/tube assembly. (Figure 1)
